Site Inspection, Jason Shumway, Picture Rock Quarry, S/037/099.

San Juan County, Utah

Photographs
S/037/099, Picture Rock Quarry, Jason Shumway
Inspection Dated: March 19, 2004; Report Dated: April 5, 2004

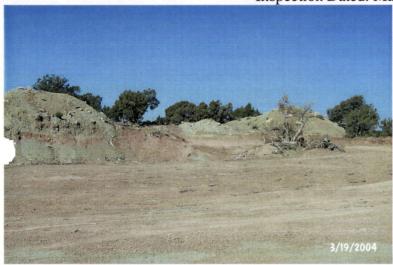
Photo 1.

The site has been regraded to a smooth, nearly flat surface (Photo 3). I did not see any vegetation. Photo 1 shows a pile of material remaining on the west side of the quarry, and Photo 2 is the outslope on the east side.

To establish vegetation, the operator needs to, foremost, roughen the surface. This should be done in the fall and should also be done almost immediately before seeding. Since the site is nearly flat, it does not need to be extremely rough, but I recommend that it be ripped at least one foot deep with ripper shanks no more than about three feet apart. Species that might be included in a seed mix are fourwing saltbush, Indian ricegrass, galleta, streambank wheatgrass, bottlebrush squirreltail, and possibly some introduced species, like crested wheatgrass, Siberian wheatgrass, and Russian wild rye. The Bureau of Land Management may object to the use of introduced species.

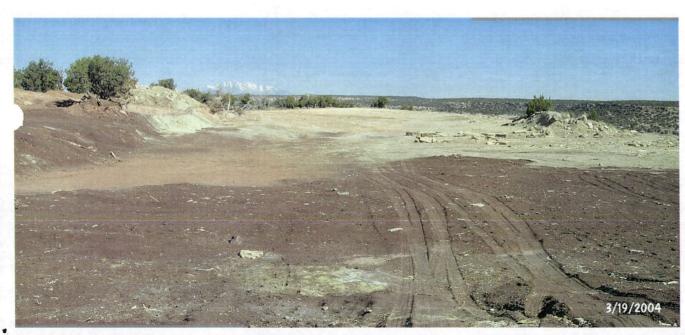
Photo 3.

The operator did not request a variance from revegetation requirements in the Notice of Intention, so the revegetation standard is 70 percent of the cover in adjacent undisturbed areas. I did not attempt to measure offsite vegetation, but it was clear the site does not have 70 of the cover in the adjacent pinyon/juniper community.
